In the recently published Nuralite Flat Roof Design Guide V2, on page 51, we wrote:

Nuralite stands by this statement. For clarity, we would add that it applies to all thermoplastic membranes such as TPO, TPE, PVC or KEE. This discussion document has been written because the statement above has been queried so we see a need for further explanation. This technical document will educate the reader so they can make an informed decision in future.

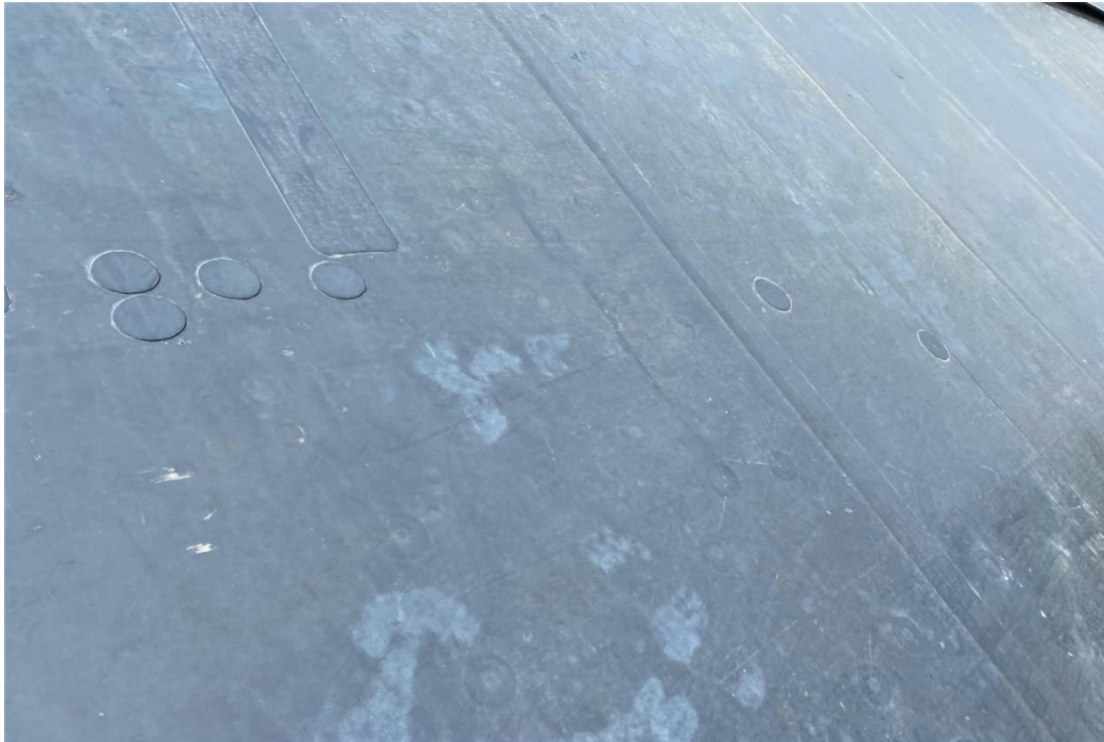
Figure 3. Seven patches in this area – Material 1.1mm, Age approx. 3 years.

Low puncture resistance provides a risk for maintenance traffic especially. If the membrane is easy to damage, although a penetration can be patched, damage may have occurred to the building during the time before the hole is identified and repaired. The biggest challenge is that any entrapped moisture will potentially create issues in future in the form of blisters.

Nuralite recommends the top ply of the membrane to be a minimum of 0.7mm thickness above the scrim for superior durability.

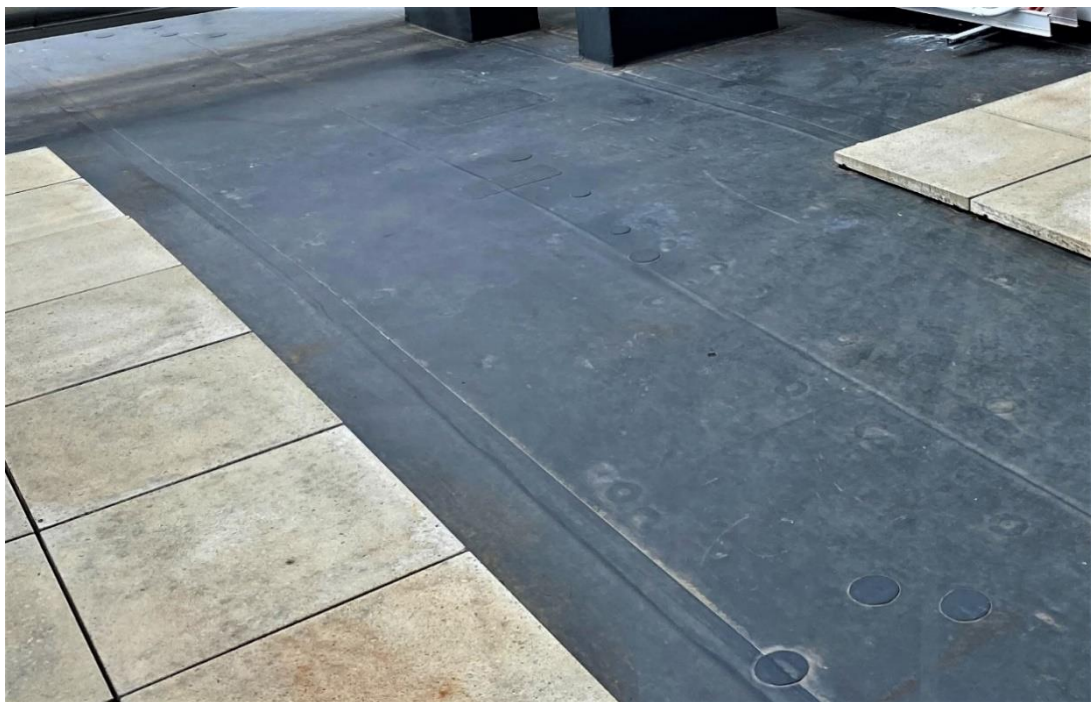
Figure 4. At least 12 patches in this area - Material 1.1mm, Age approx. 3 years.

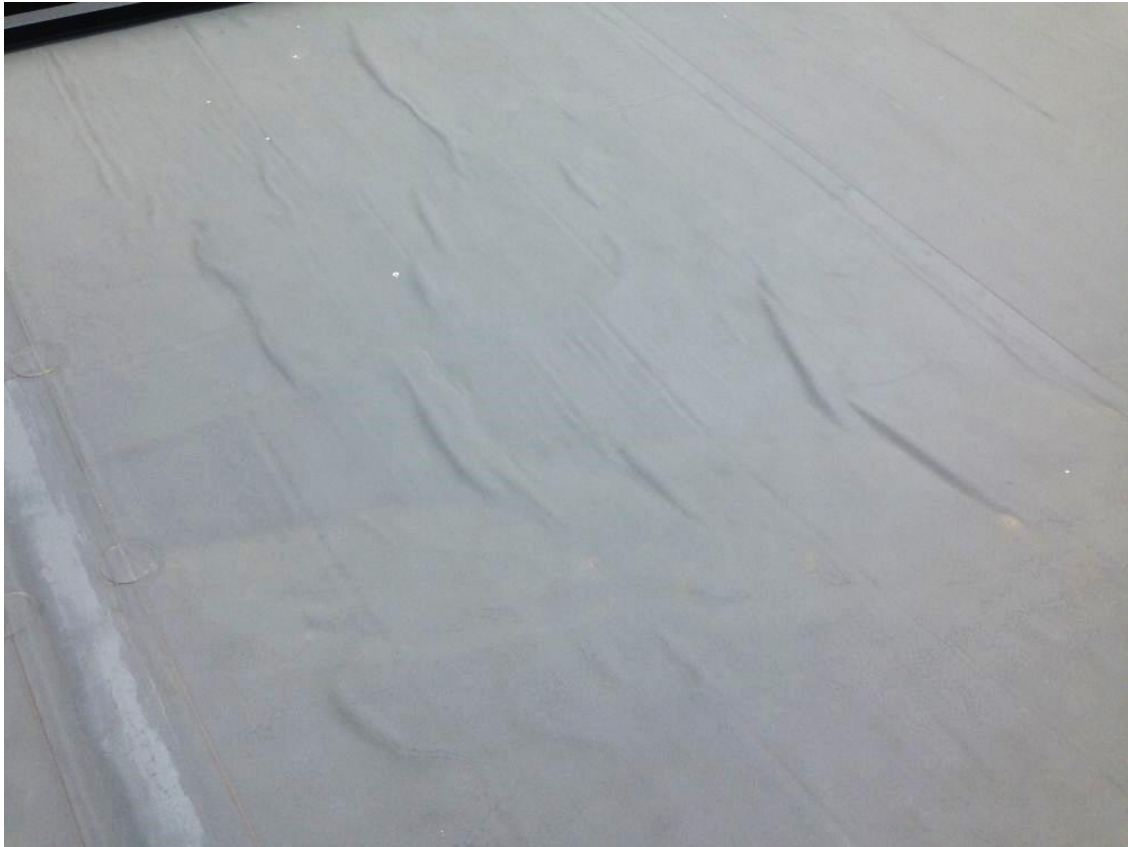
Figure 5. Three patches (of 6 on the roof). Material 1.2mm, age 2 years

An additional note is that Figures 5 & 7 show the membrane debonding from the substrate. While poor installation may also be a contributor, this can also be caused as a result of the membrane putting a high load on the adhesive due to thermal movement.

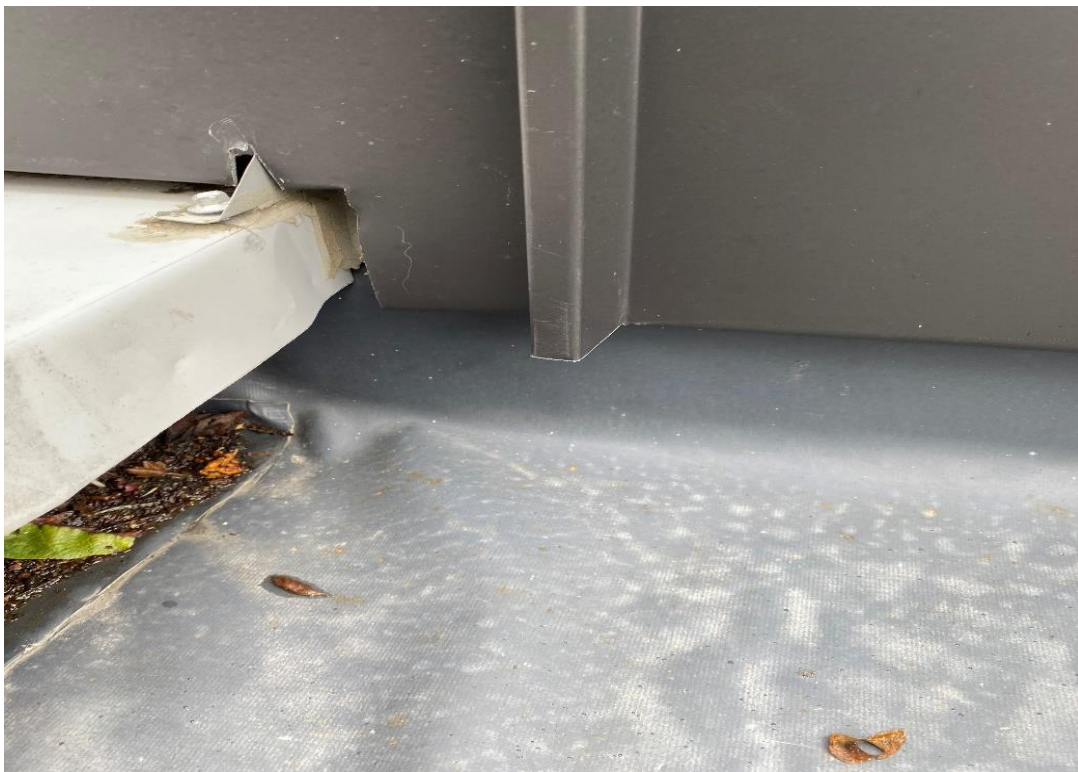
Figure 7. Membrane in sole of gutter appears deteriorated compared to upstand. Material 1.1mm, Age approx. 3 years.

Once there is no material above the reinforcing scrim it would be considered that the product has failed and is no longer watertight.

Nuralite recommends that thermoplastic membranes should be installed using light colours such as white or light grey to increase longevity of performance.

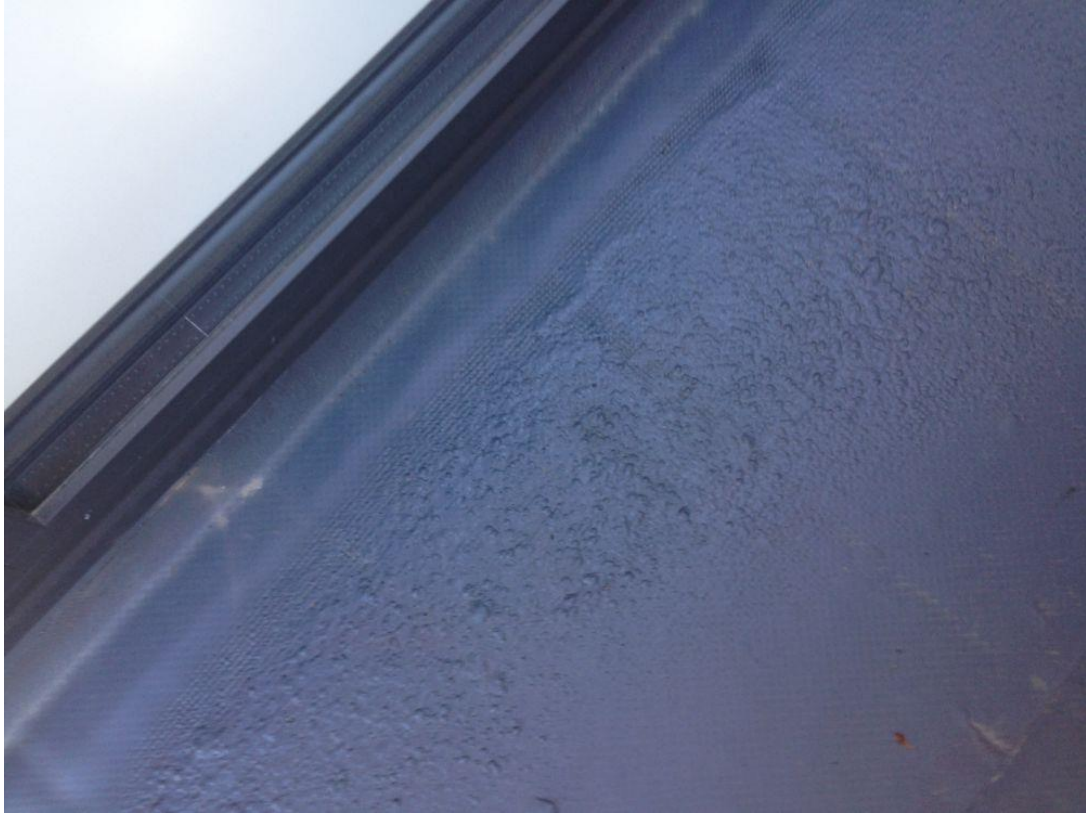
Figure 8. Membrane blistering from heat from upstand reflection. Material 1.2mm, Age approx. 4 years

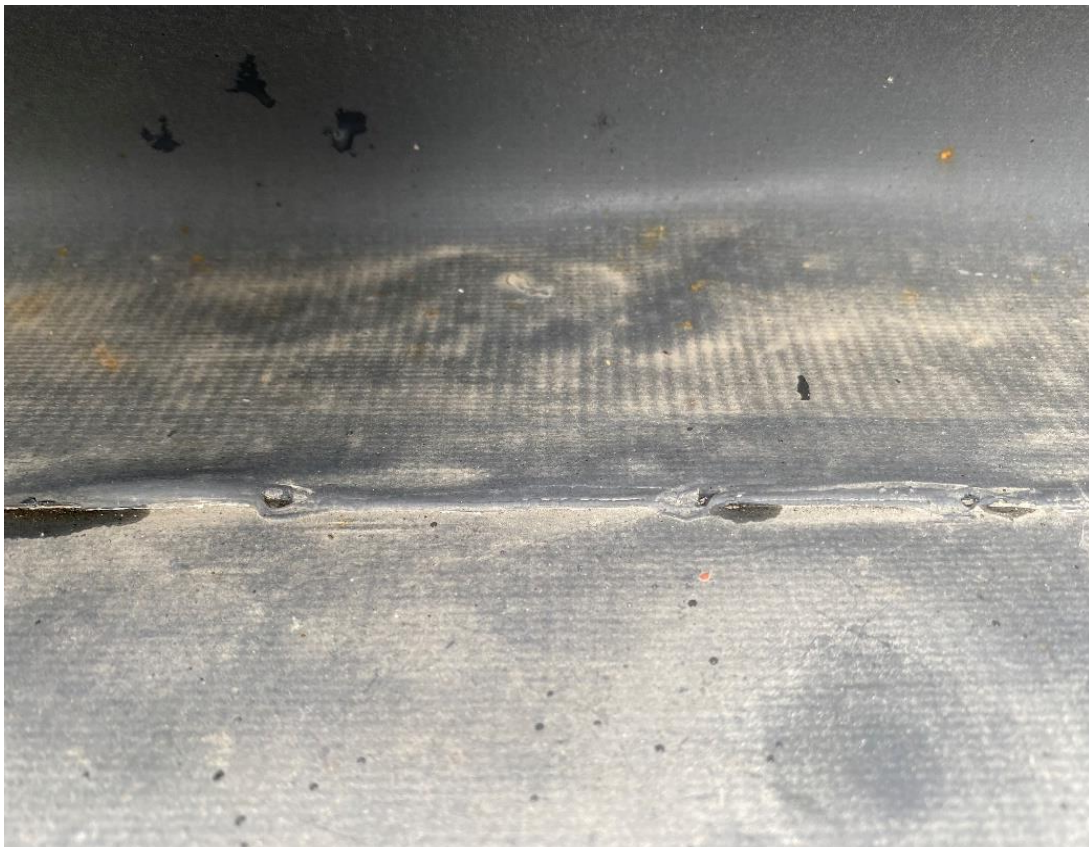
Figure 9. Closeup of membrane in sole of gutter, Material 1.1mm, Age approx. 3 years.

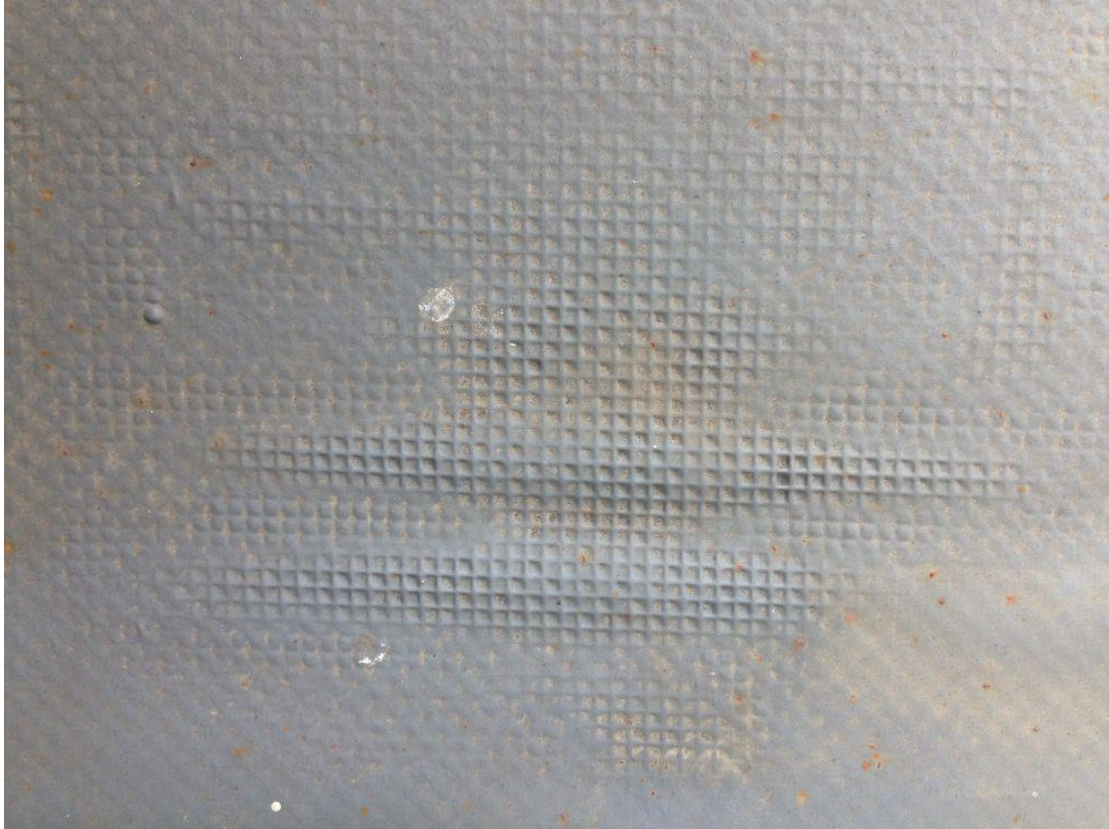
Figure 10. Close up, Material 1.2mm, Age approx. 4 years.
