## Colour Testing Sample Range

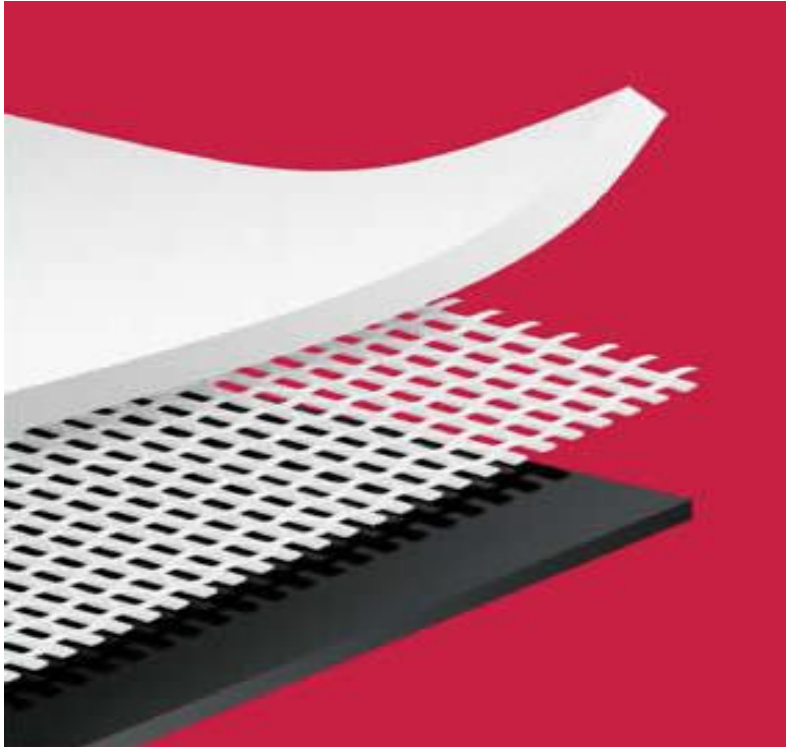
*Thermoplastic sheet build up (exploded view)*

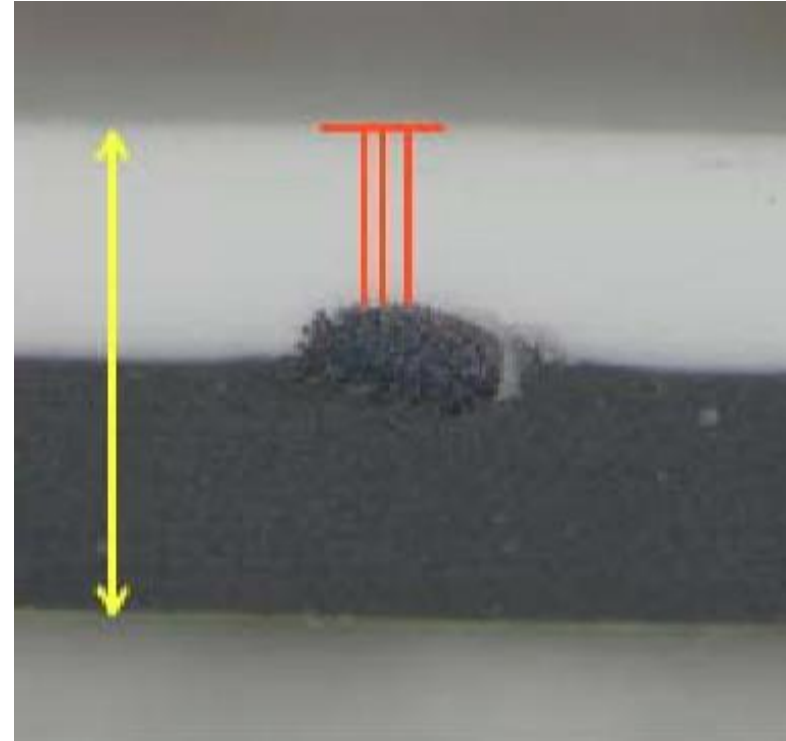
*Difference between total thickness (yellow arrow) and thickness above scrim (orange lines)*

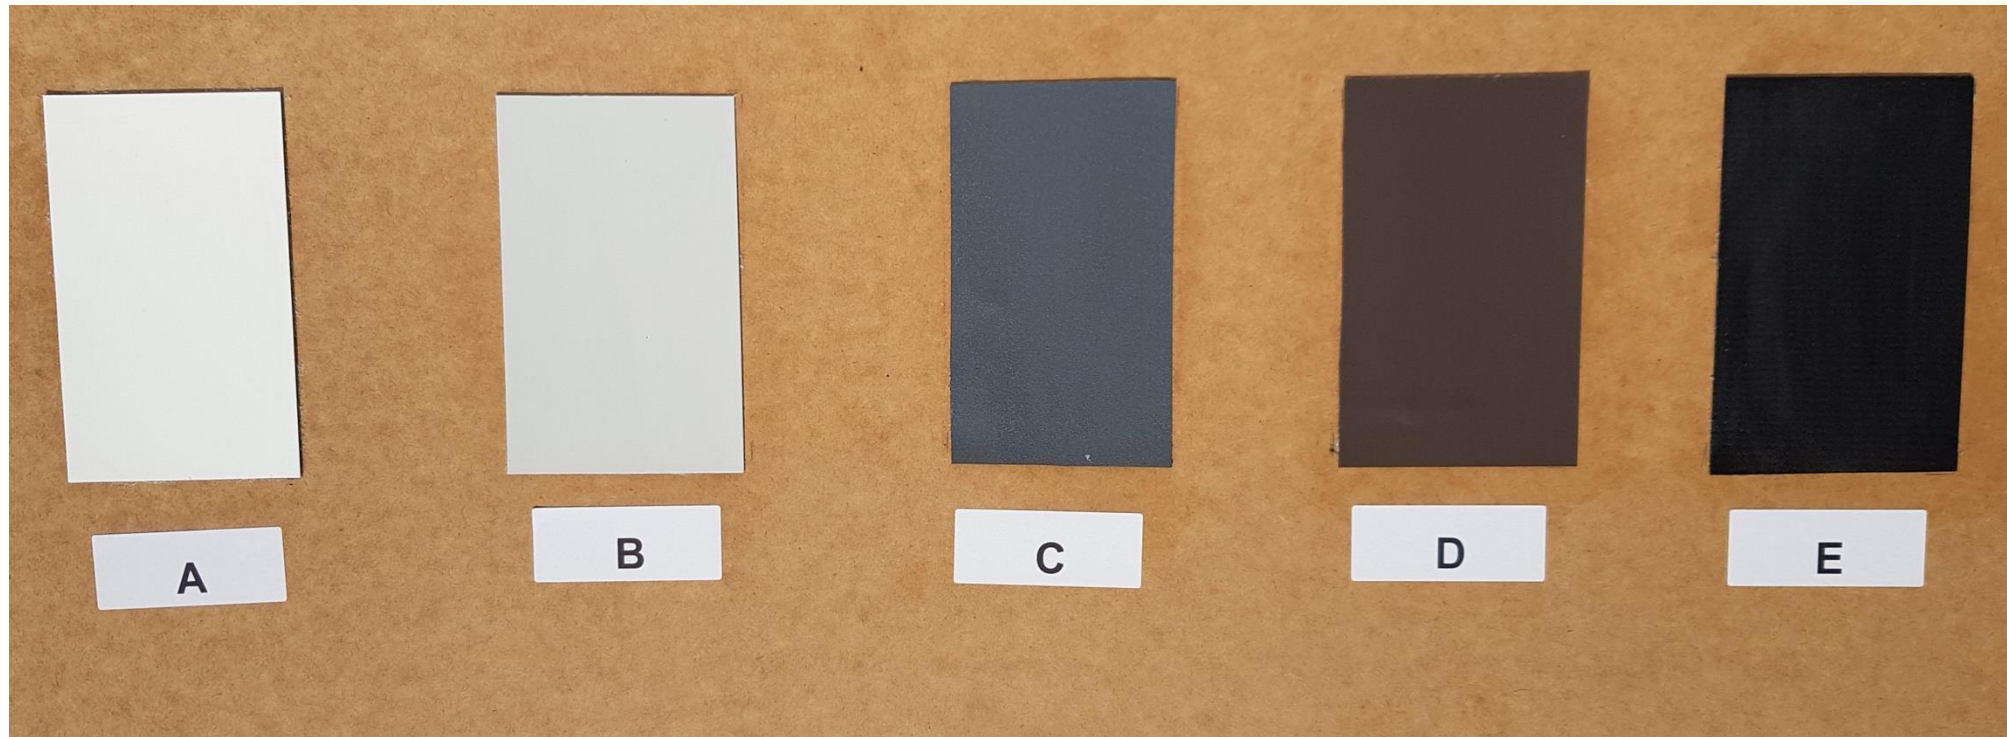
| SinglePly heat test | | 12/03/2021    Nuralite, 60D Leon Leicester Avenue, Auckland | | | | |
| Time | Ambient air temp | Membrane A | Membrane B | Membrane C | Membrane D | Membrane E Notes |
| 1.30 PM* | 22.0 C° | 46.8 C° | 62.3 C° | 94.2 C° | 86.7 C° | 99.6 C°<br>*solar noon |
